7.7 List of Figures

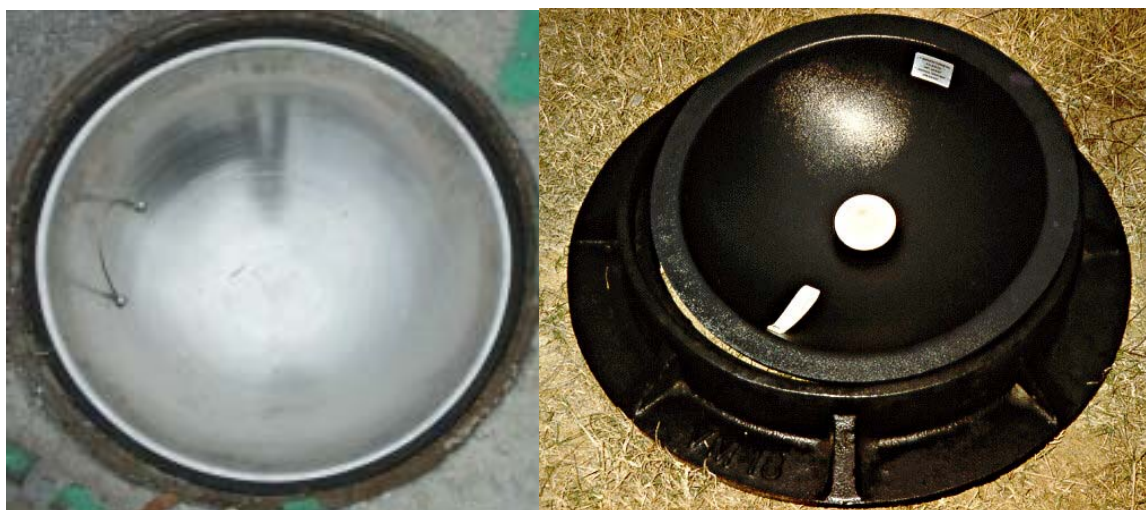
Figure 7-40. Manhole 16

Other available manhole pans. Note: pan will not allow locking lid to be installed.

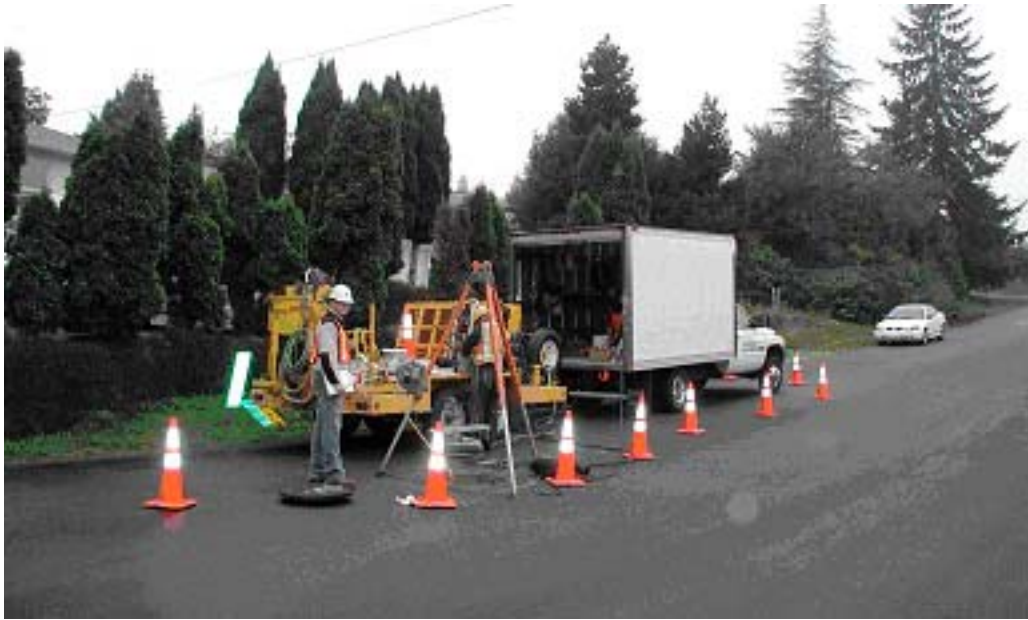
Figure 7-41. Manhole 17

Chemical grouting operation for manholes.

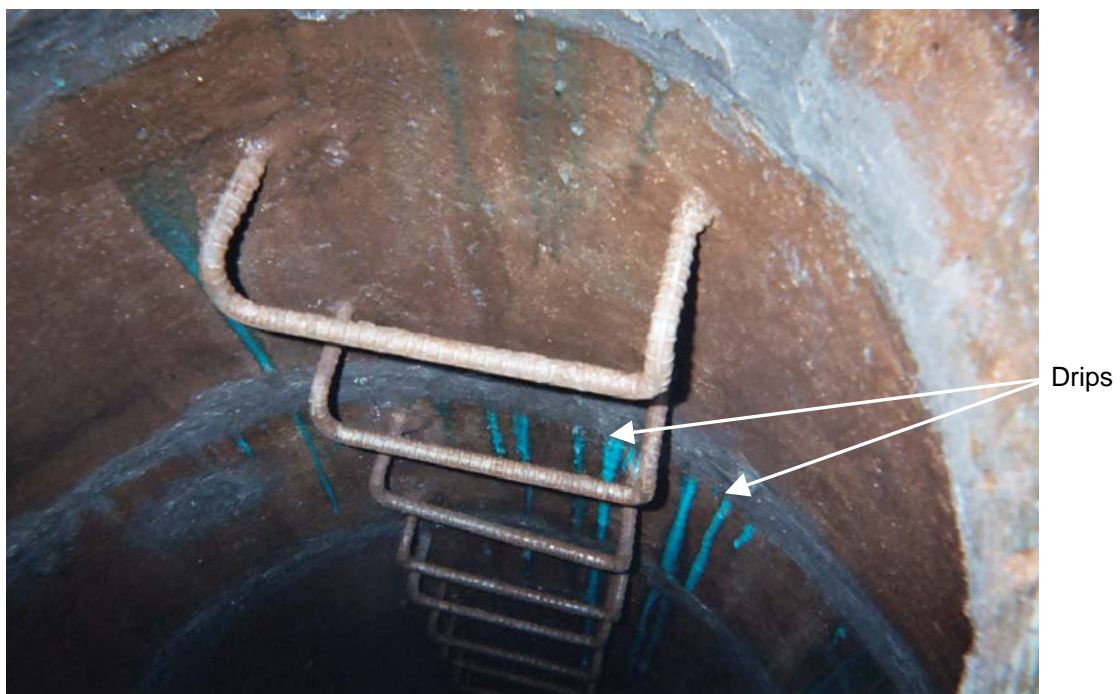
Figure 7-42. Manhole 18

Drips are chemical grout leaking back into manhole through defects.

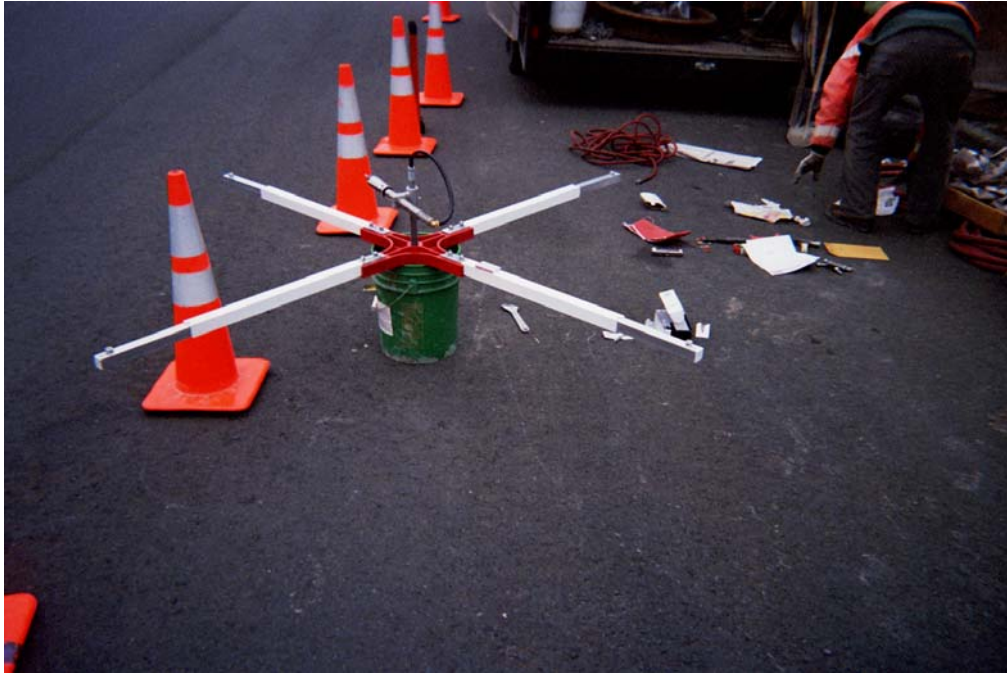
Figure 7-43. Manhole 19

WHIRLyGIG tool assembled.

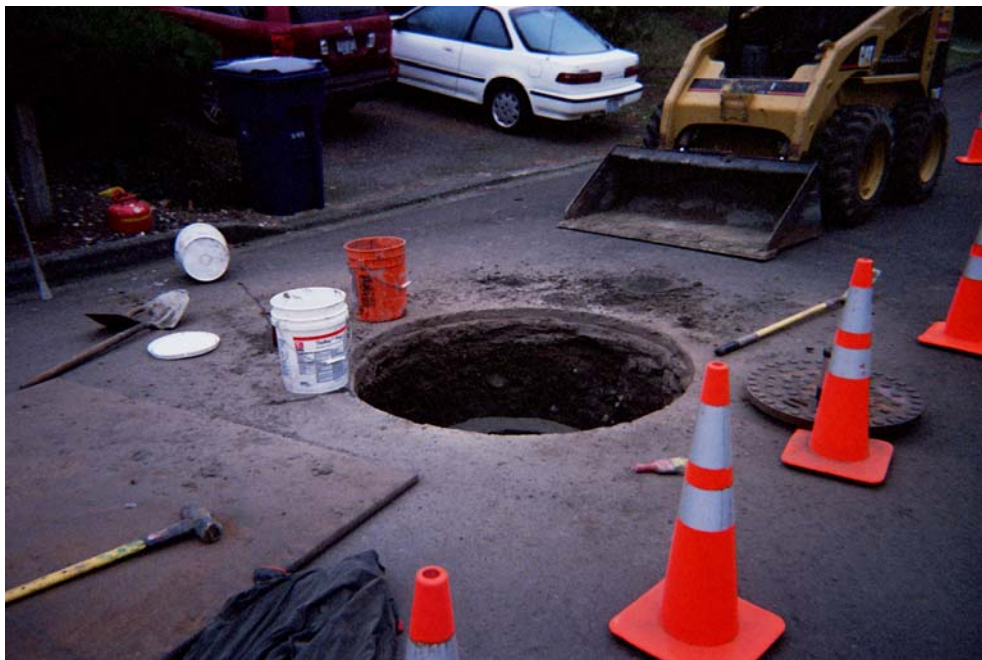
Figure 7-44. Manhole 20

Manhole with lid, frame, and leveling rings removed; ready for WHIRLyGIG installation.

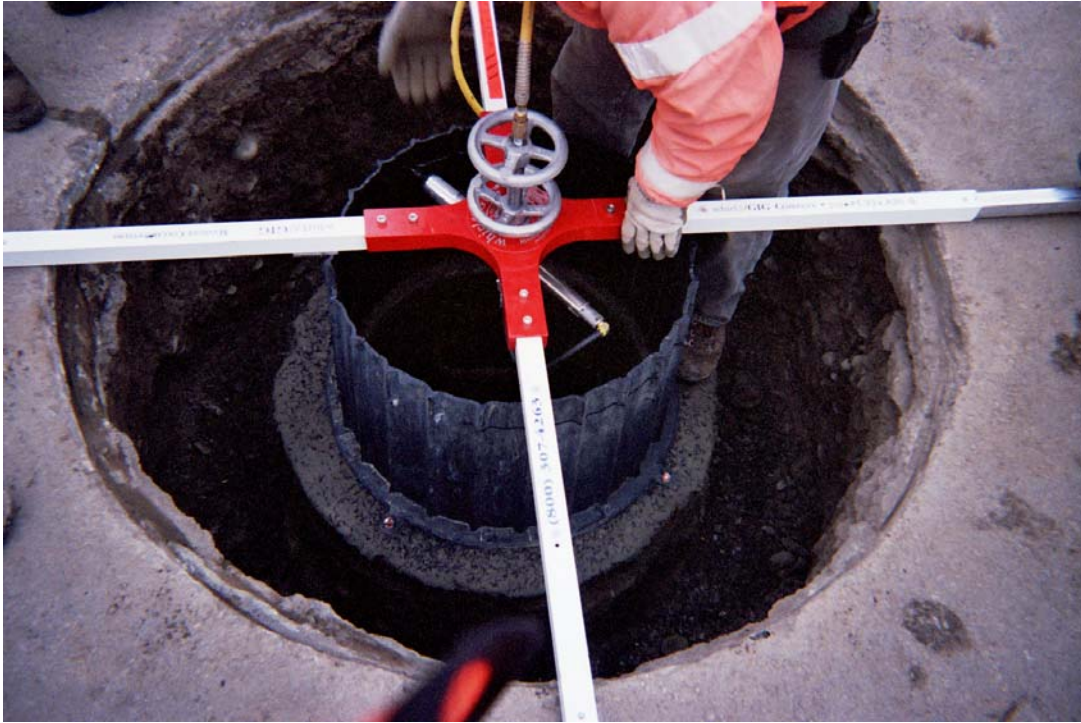
Figure 7-45. Manhole 21

Plastic concrete form in place and being trimmed by the WHIRLyGIG tool.

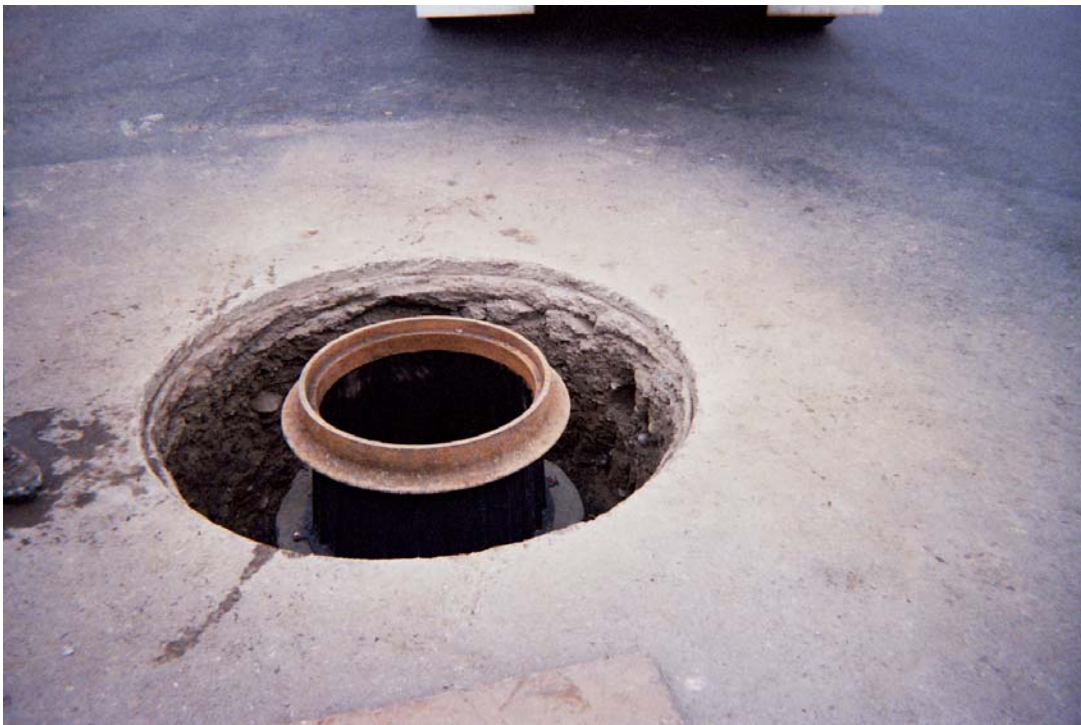
Figure 7-46. Manhole 22

Frame in position on top of plastic concrete form.

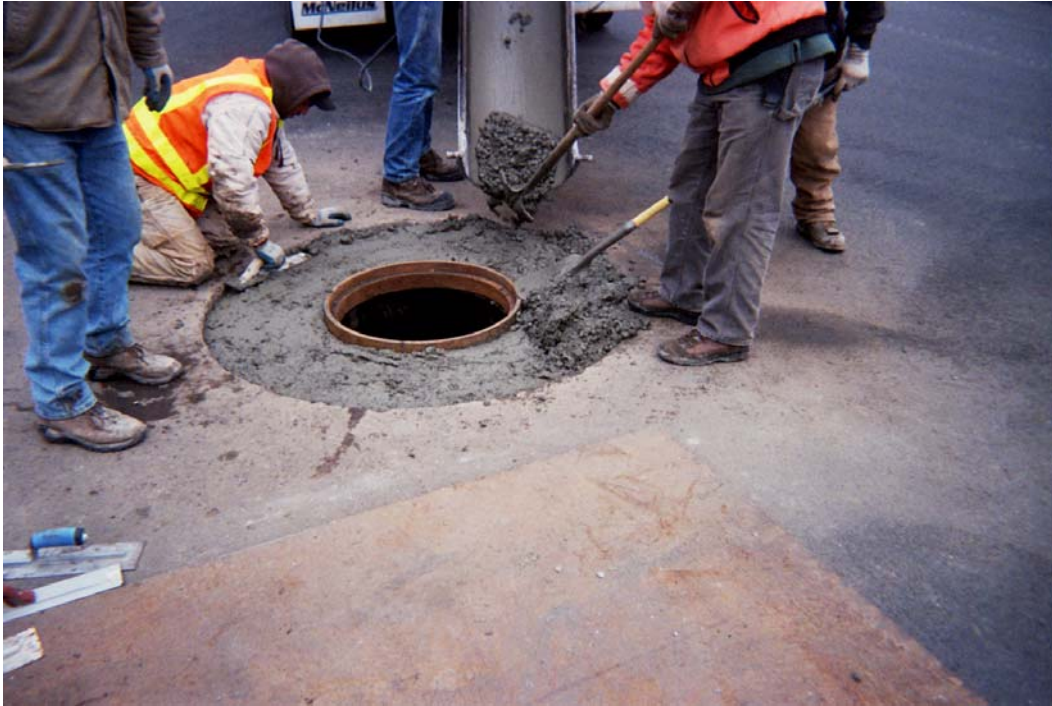
Figure 7-47. Manhole 23

Concrete being poured to create solid concrete collar.

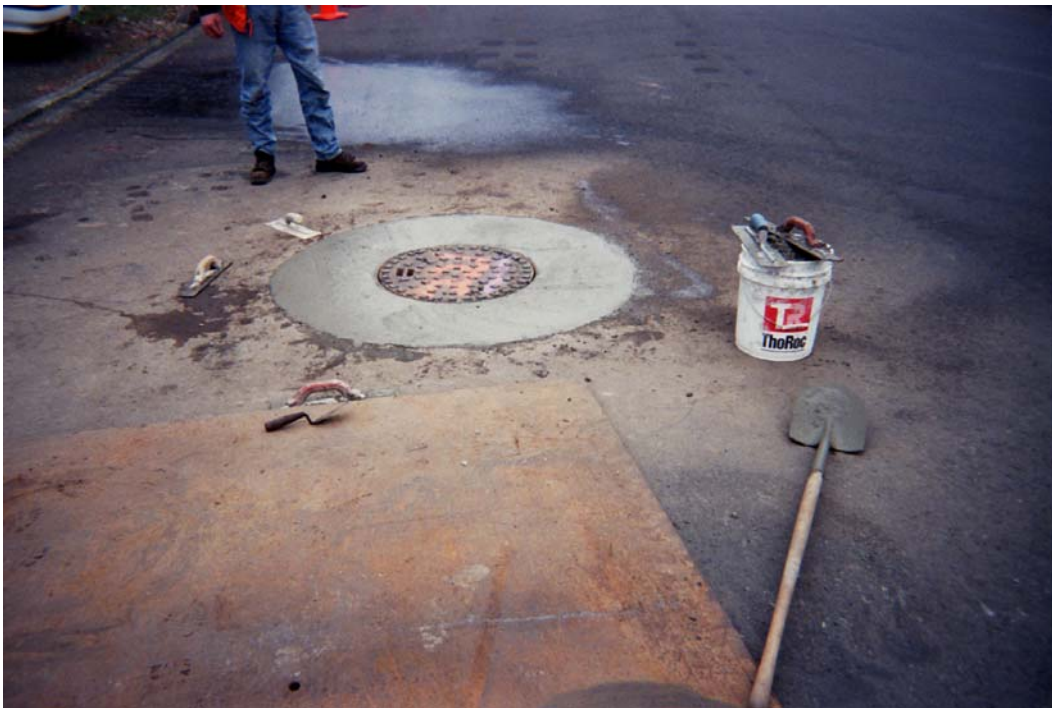
Figure 7-48. Manhole 24

Completed concrete collar. Steel plate is required to protect fresh concrete and must be blocked up to avoid touching concrete. This may preclude allowing cars to drive over the plate.

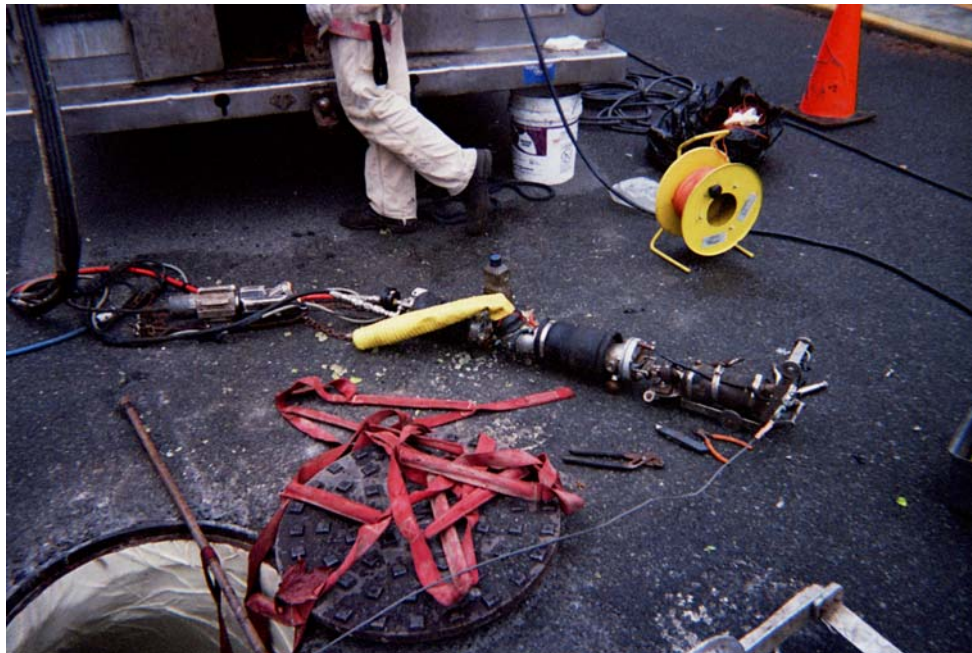
Figure 7-49. Lateral and Side Sewer 1

Specialty packer for chemical grouting the connection between a lateral and sewer main. Yellow packer will inflate inside the lateral.

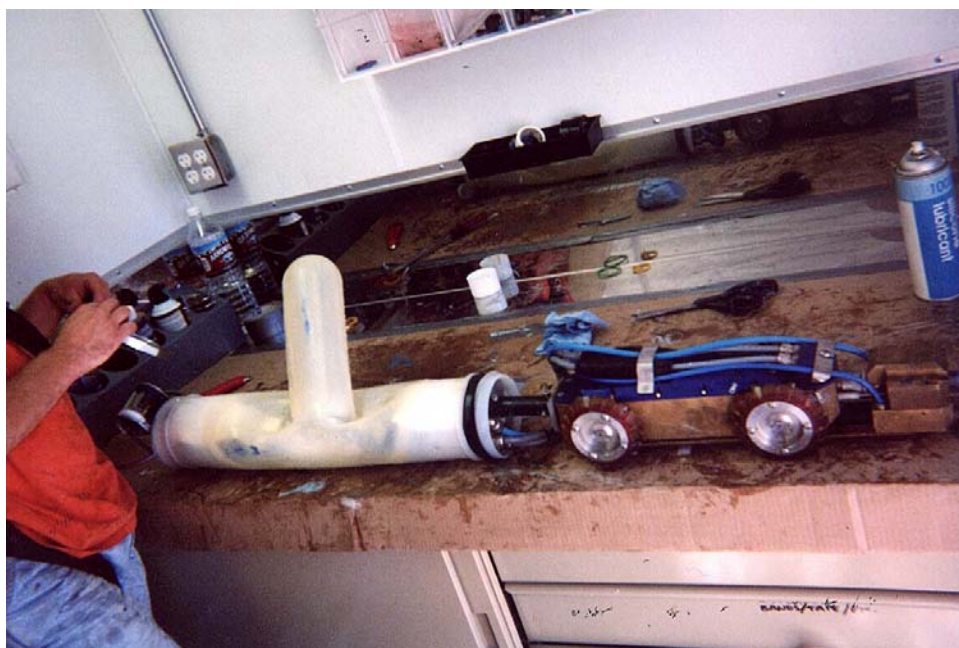
Figure 7-50. Lateral and Side Sewer 2

TOP HAT™ packer. Wheeled robot moves packer into position. White bladder will place TOP HAT™ into position. Bladder contains ultraviolet (UV) lights and a closed circuit television (CCTV) camera.

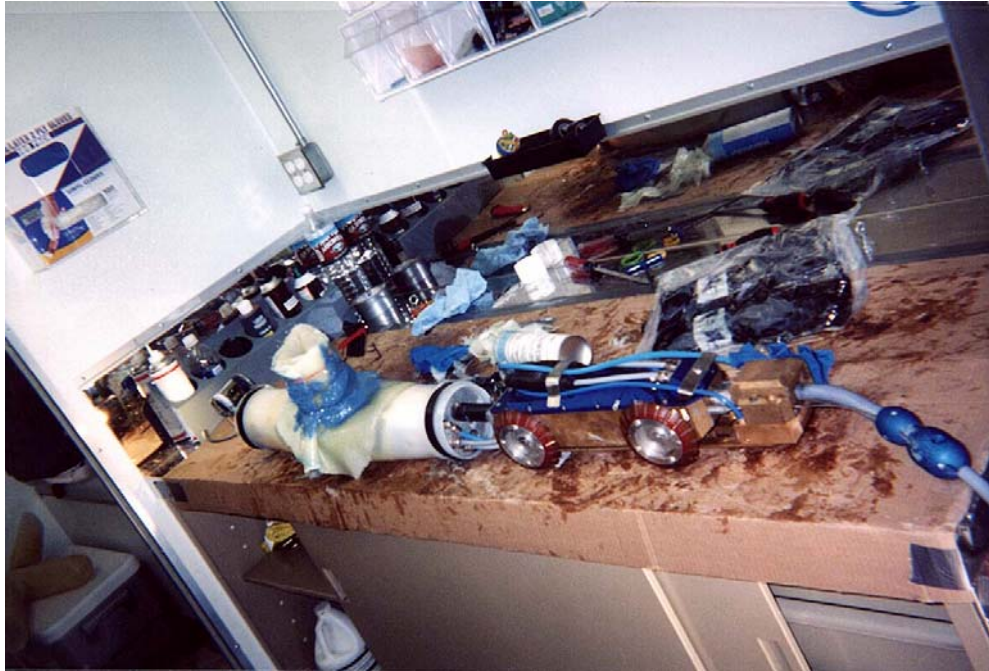
Figure 7-51. Lateral and Side Sewer 3

TOP HAT™ packer with TOP HAT™ in position. Blue paste is epoxy that will seal TOP HAT™ to service connection.

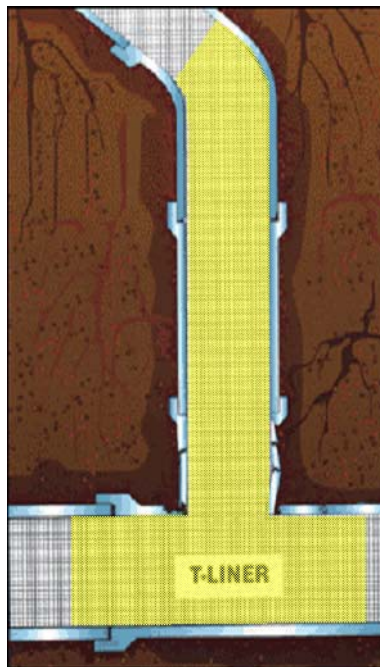
Figure 7-52. Lateral and Side Sewer 4

Schematic of a T-Liner®.

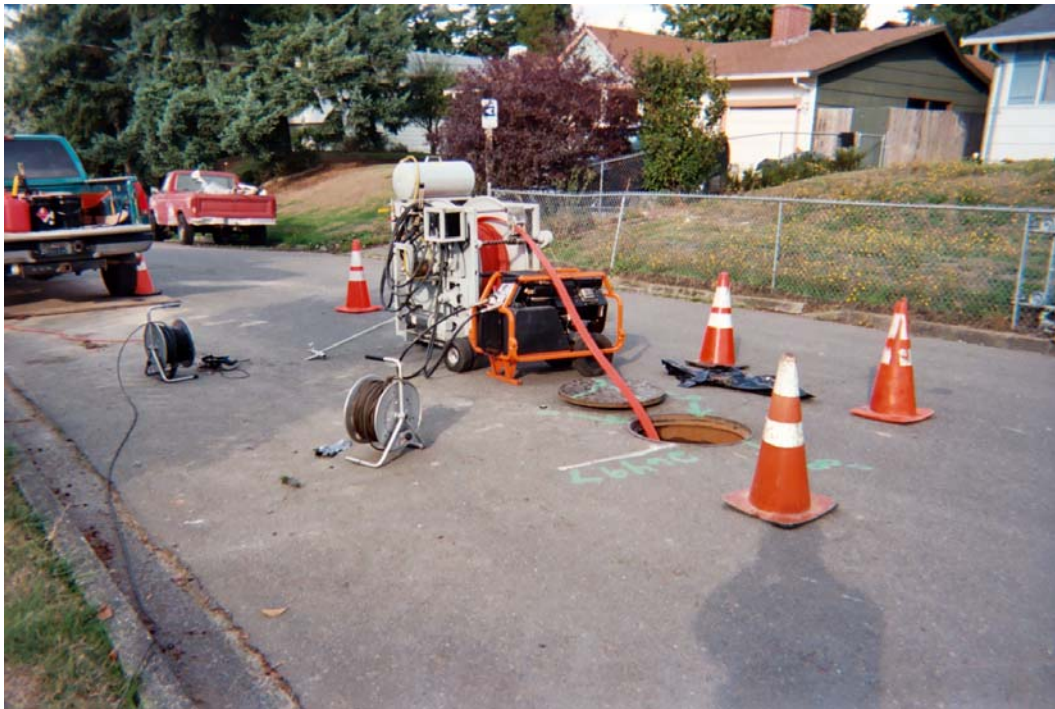
Figure 7-53. Lateral and Side Sewer 5

T-Liner® installation equipment located at downstream manhole. Similar equipment is located at the upstream manhole as the liner is placed inside the sewer main.

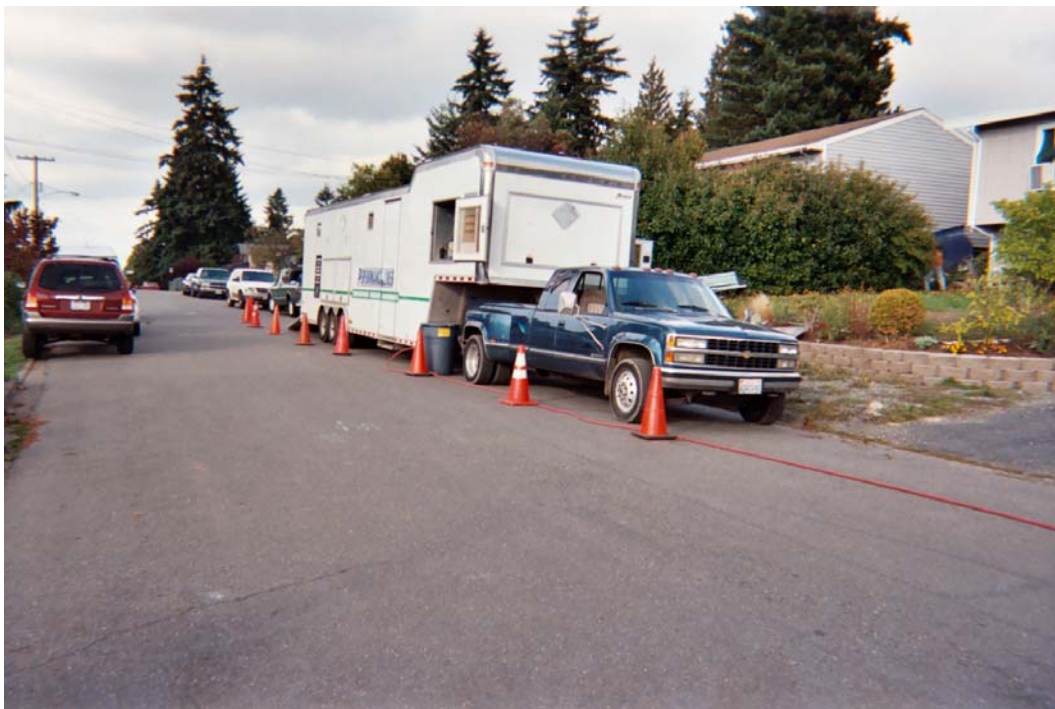
Figure 7-54. Lateral and Side Sewer 6

Trailer for field wet-out of T-Liners®.

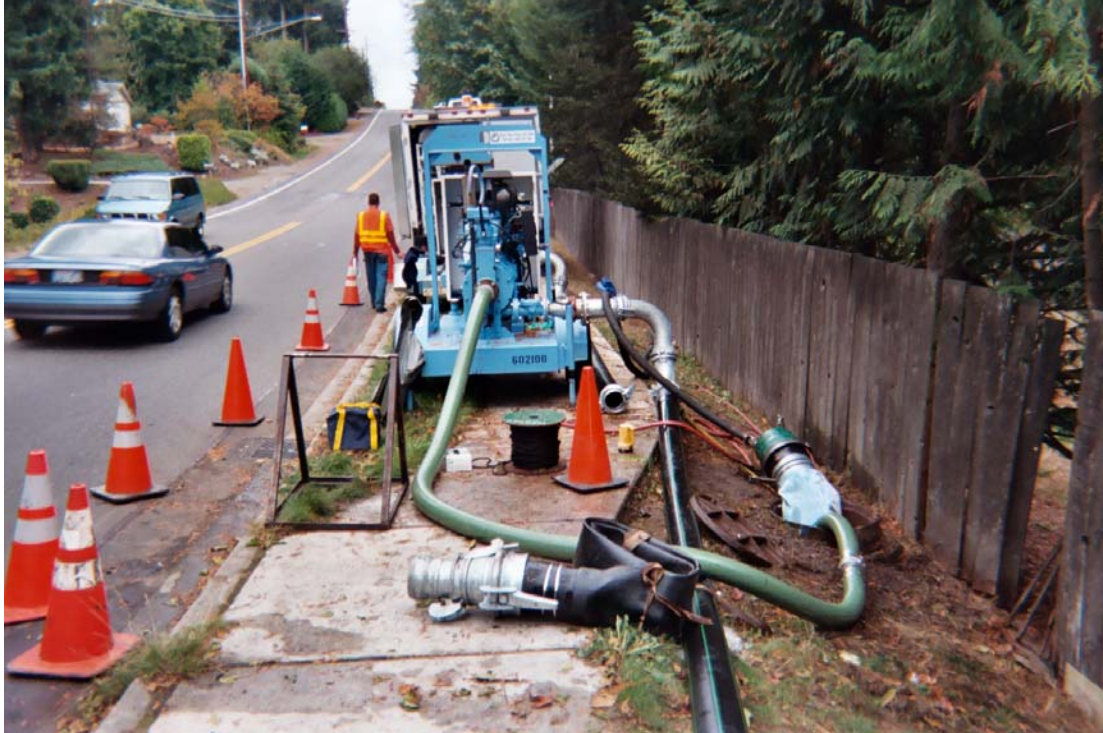
Figure 7-55. Bypass Pumping System

Large bypass pumping operation to allow construction of improvements in a section of sewer main.
